Remedial Investigation Report For Operable Unit 6 at the Libby Asbestos Site Libby, Montana

16 April 2014

BNSF Railway Company
800 North Last Chance Gulch, Suite 101
Helena, Montana 59601

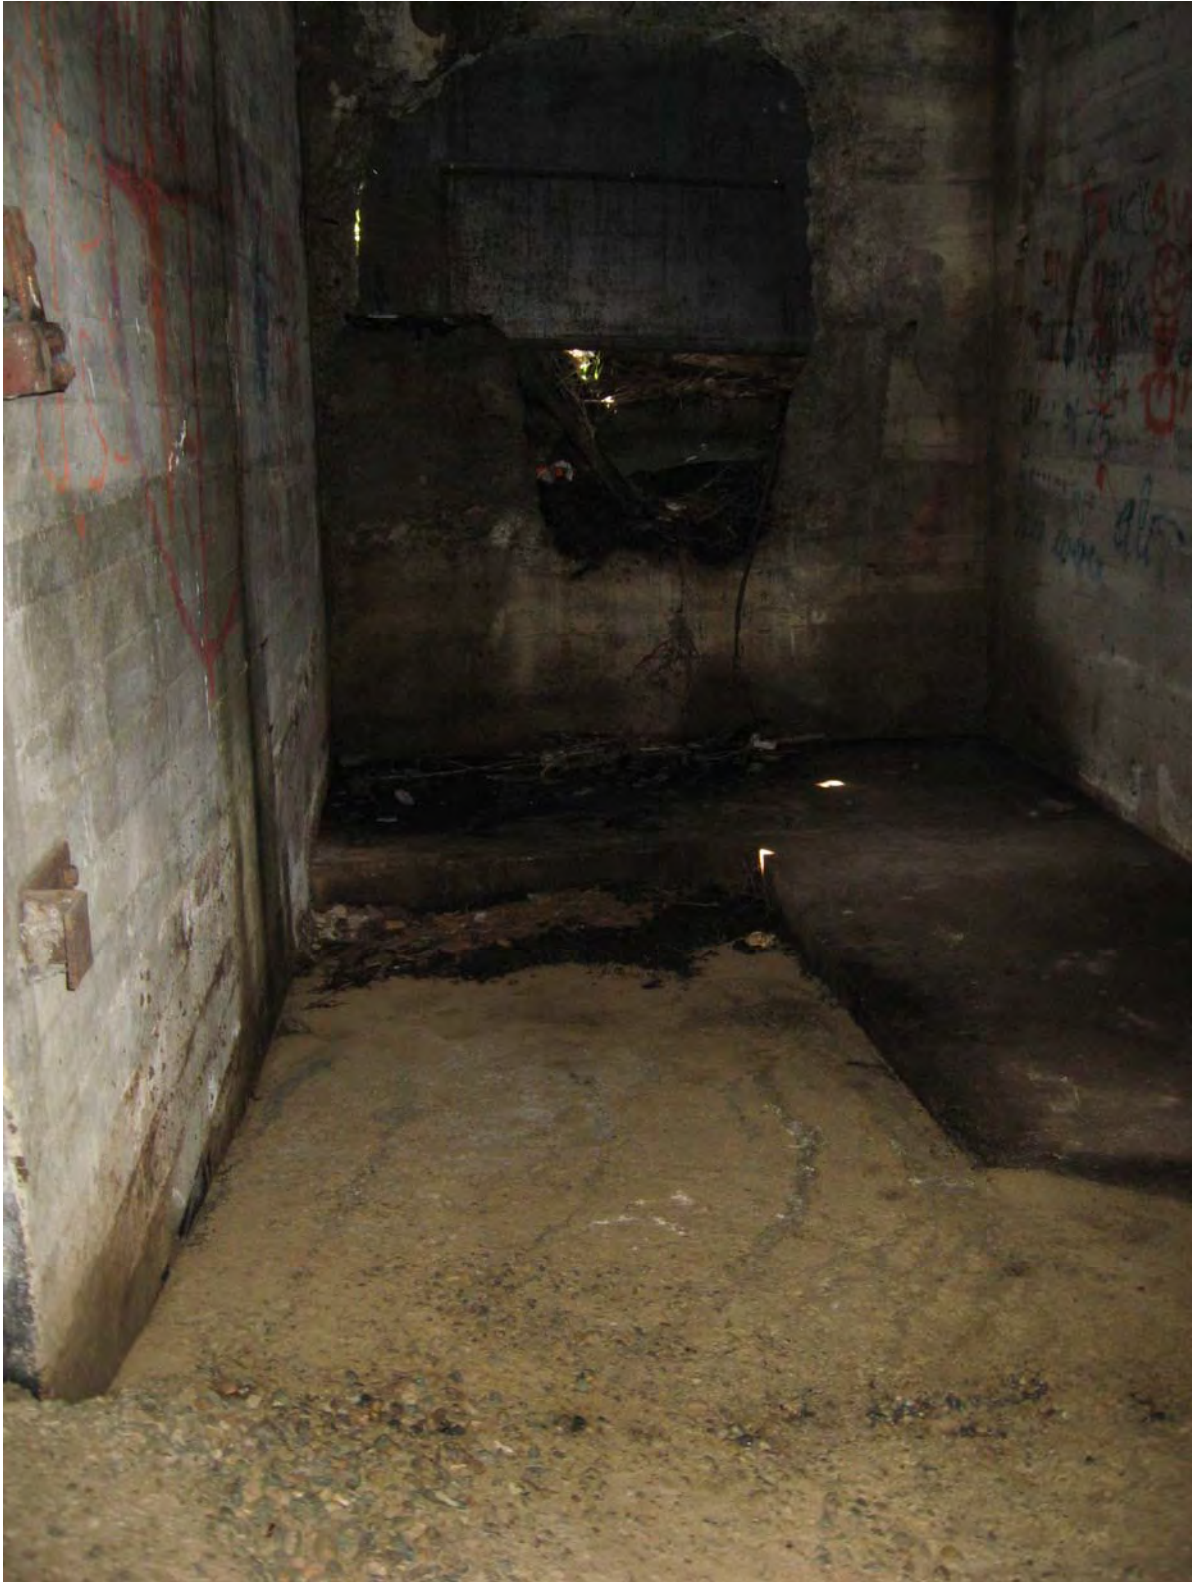
Photograph 1. Floor of concrete bunker showing incomplete concrete cap. View to the West.

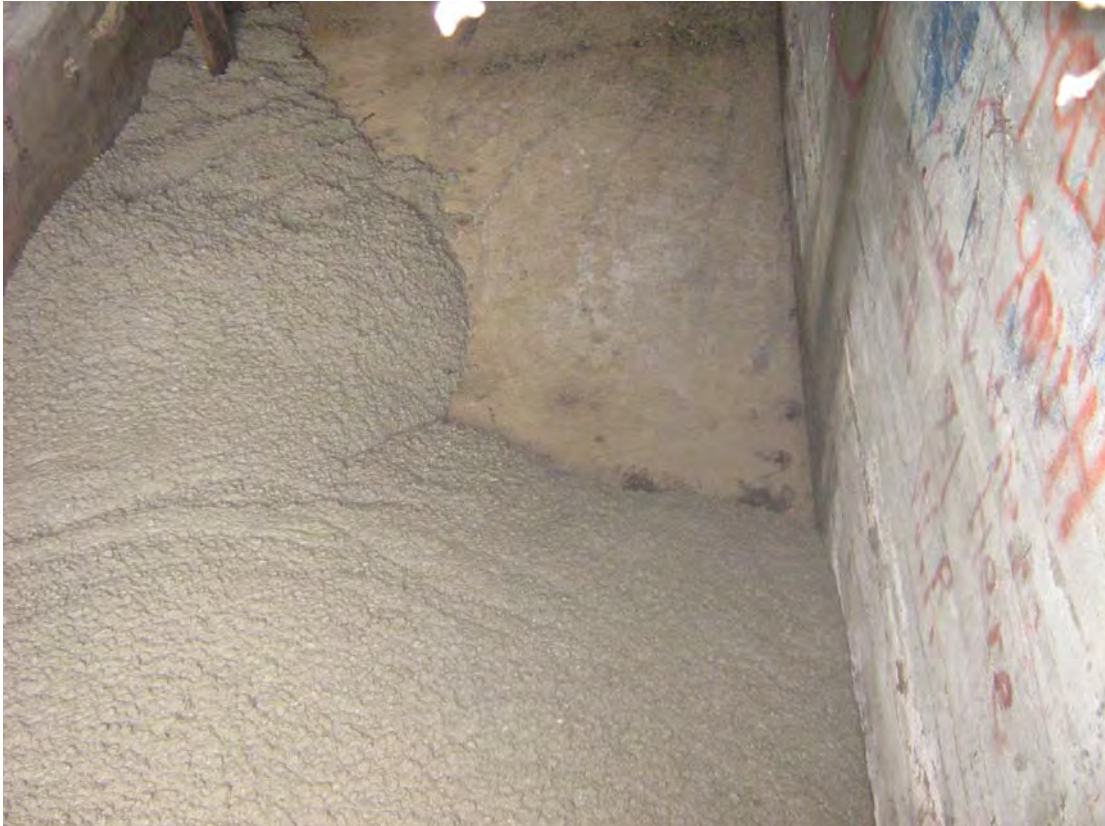
Photograph 2. Floor of concrete bunker showing completed concrete cap. View to the East.

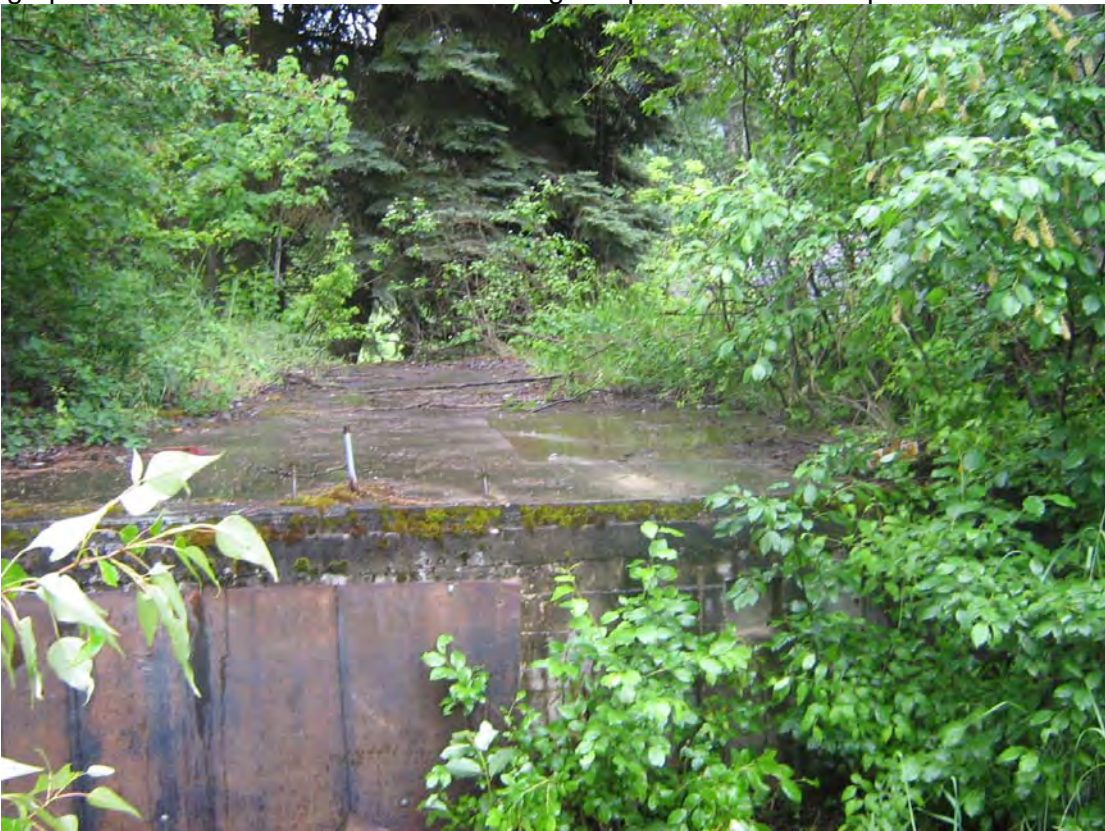
Photograph 3. View of bunker showing reattached steel plates. View to the East

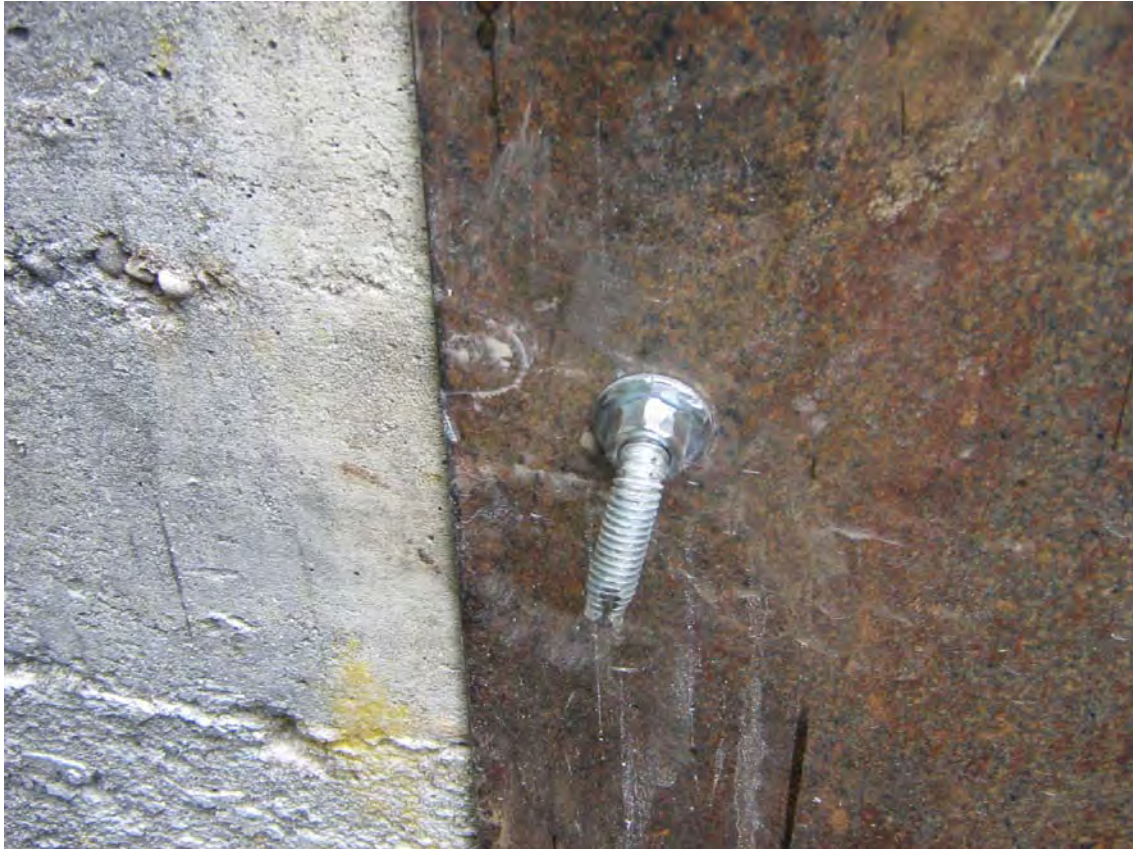
Photograph 4. Close up of anchor bolt.
